**Issue Date**  
15<sup>th</sup> September 2021

**Reference Number**  
23458

## Asbestos Demolition Survey

**Site Address**  
Former Hope High School  
Tanhouse Road  
Skelmersdale  
WN8 6BA

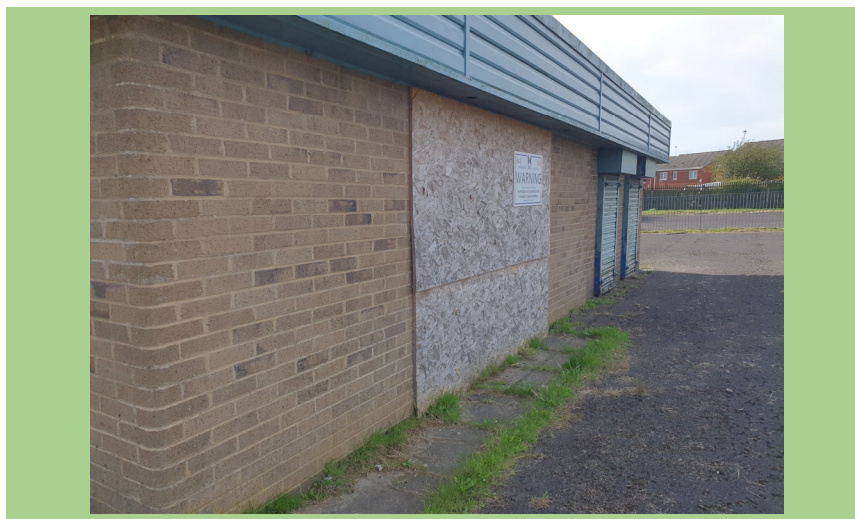
| Sample Number | 49 NA | Floor Plan Colour | Grey hatched |

- Room G.62 on the ground floor could not be accessed as the entrance was boarded over utilising non-standard screws.
- Room G.63 on the ground floor could not be accessed as the room is within an area sealed shut using metal sheeting.

| Floor, Room | Ground floor, G.62 | Location | Externally accessed room |

If these areas are included within the scope of the proposed demolition works, further inspection will be required once access into these areas has been organised by the client.

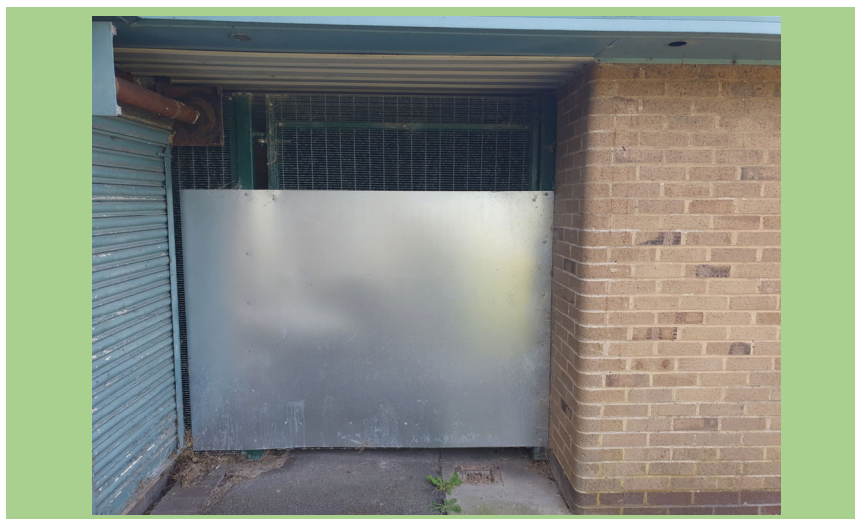
| Sample Number | 50 NA | Floor Plan Colour | Grey hatched |

| Floor, Room | Ground floor, G.63 | Location | Externally accessed room |

| Sample Number | Floor, Room | Location | Management Recommendation |
|---|---|---|---|
| 50 NA | Ground floor, G.63 | Externally accessed room | Access and inspect |

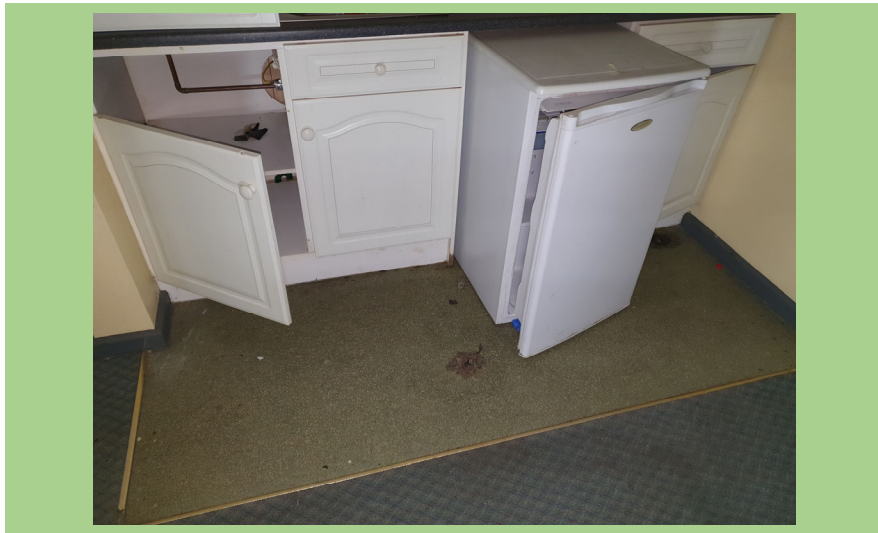
| Sample Number | 1 | No Asbestos Detected |

| Floor, Room | Ground floor, G.04 | Location | Floor |
| Material | Green linoleum | Quantity | 4 sq. m. |

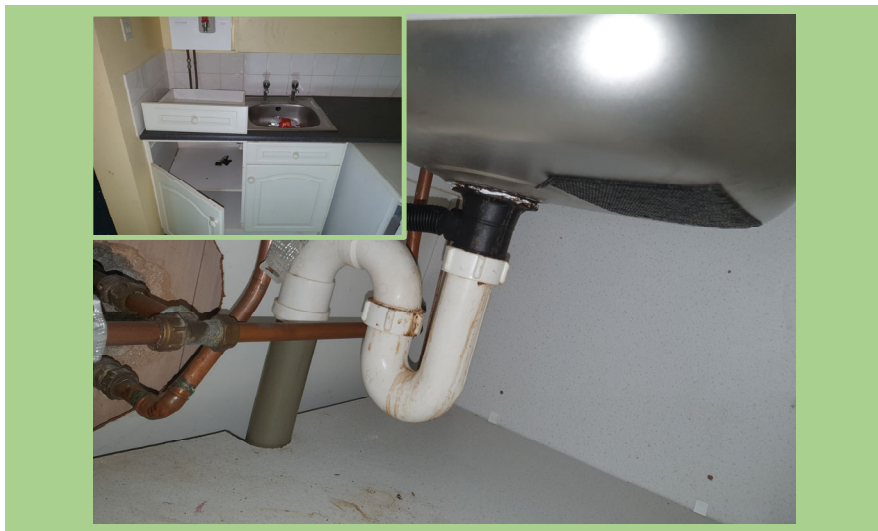
| Sample Number | 2 | No Asbestos Detected |

| Floor, Room | Ground floor, G.04 | Location | Underside of the sink |
| Material | Bitumen pads | Quantity | 2 units |

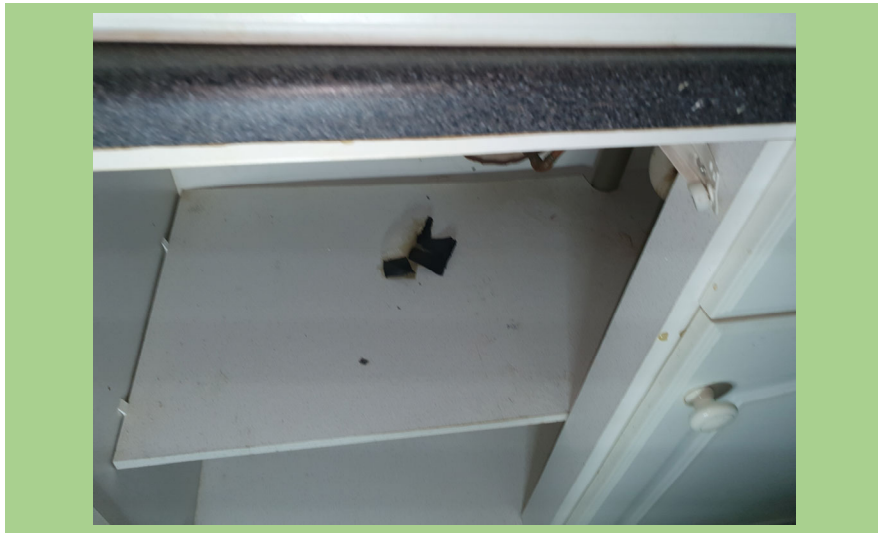
| Sample Number | 3 VI 2 | No Asbestos Detected |

| Floor, Room | Ground floor, G.04 | Location | Cupboard beneath the sink |
| Material | Bitumen pad debris | Quantity | 1 unit |

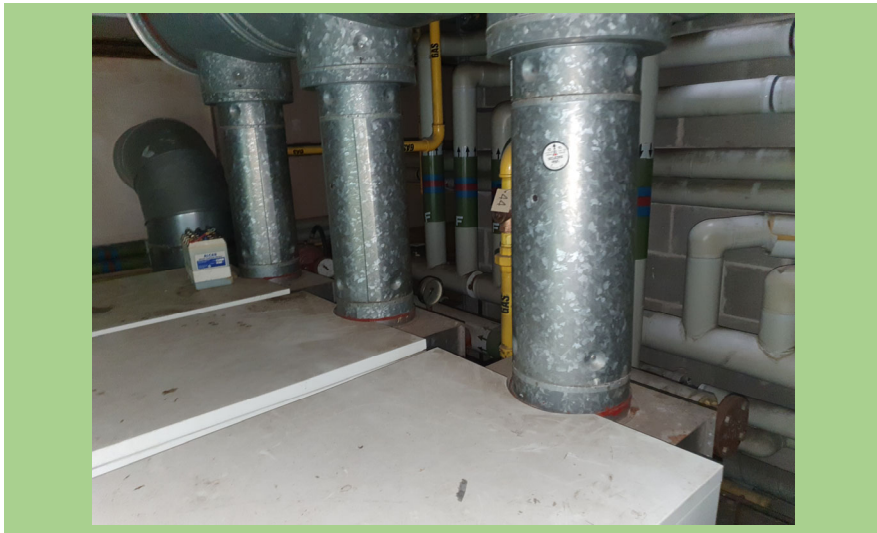
| Sample Number | 39 | No Asbestos Detected |

| Floor, Room | First floor, 1.04 | Location | Seals to the boiler flue pipes |
| Material | Red mastic | Quantity | 3 units |

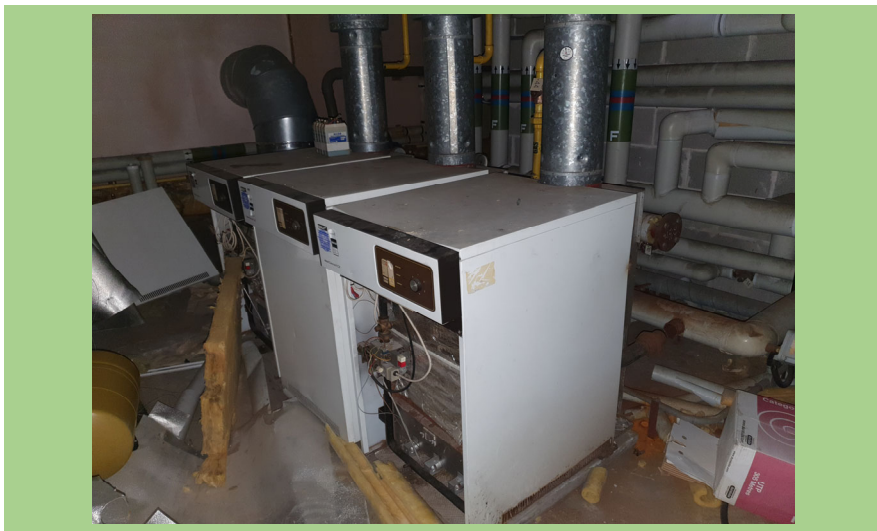
| Sample Number | 40 | No Asbestos Detected |

| Floor, Room | First floor, 1.04 | Location | Within the boilers |
| Material | Textile seals | Quantity | 3 units |

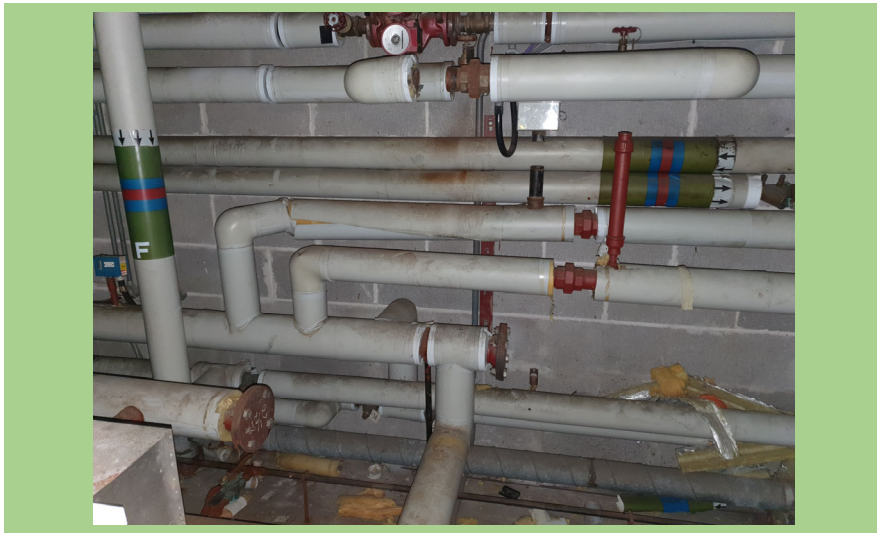
| Sample Number | 41 | No Asbestos Detected |

| Floor, Room | First floor, 1.04 | Location | Pipework flanges throughout |
| Material | Gaskets | Quantity | 20 units |

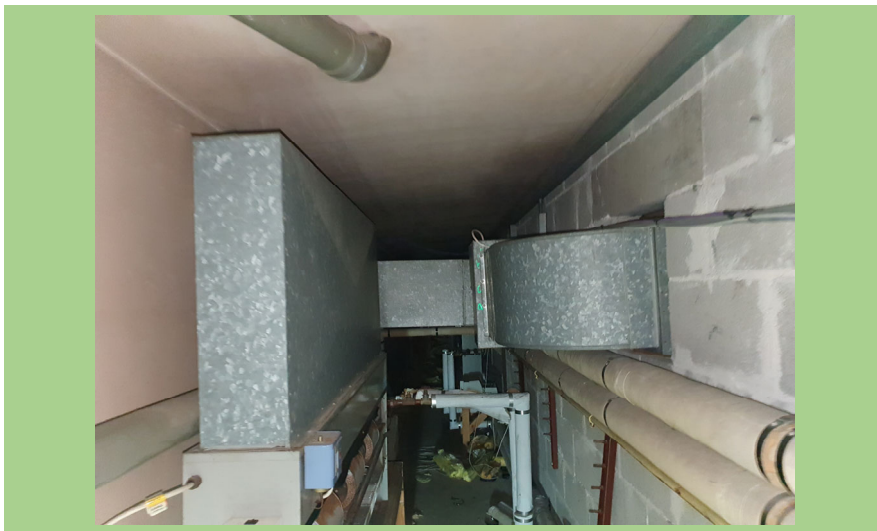
| Sample Number | 42 | No Asbestos Detected |

| Floor, Room | First floor, 1.04 | Location | Seals to the metal ventilation ductwork |
| Material | Grey mastic | Quantity | 30 lin. m. |

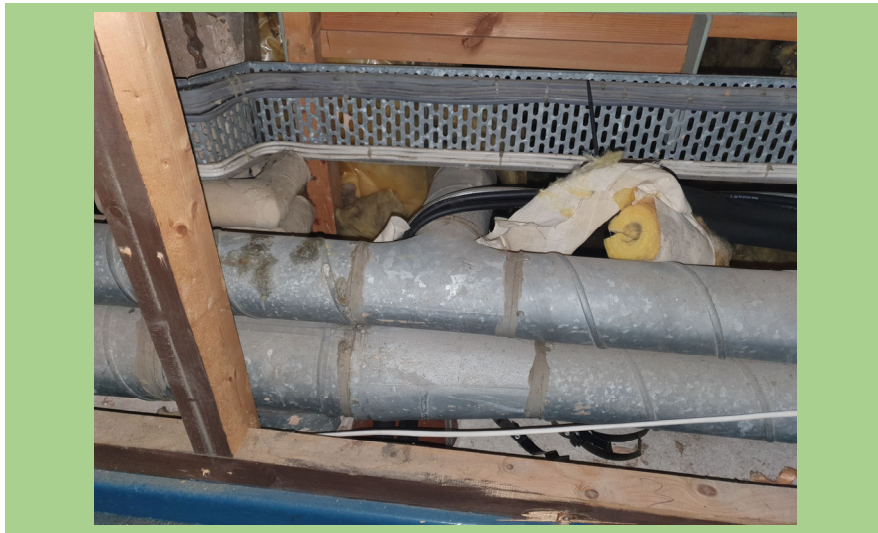
| Sample Number | 43 | No Asbestos Detected |

| Floor, Room | First floor, throughout | Location | Within the wall and ceiling voids |
| Material | Insulation | Quantity | 150 sq. m. |

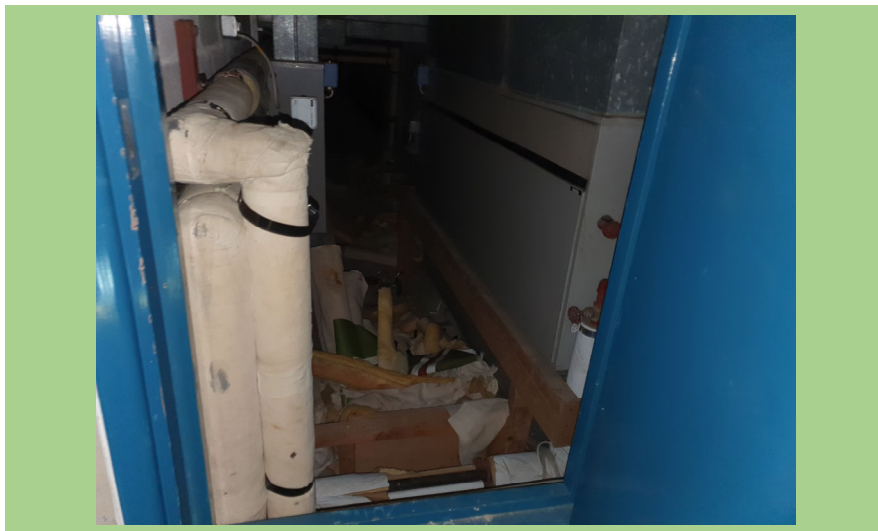
| Sample Number | 44 | No Asbestos Detected |

| Floor, Room | First floor, throughout | Location | Pipework throughout |
| Material | Insulation | Quantity | 100 lin. m. |

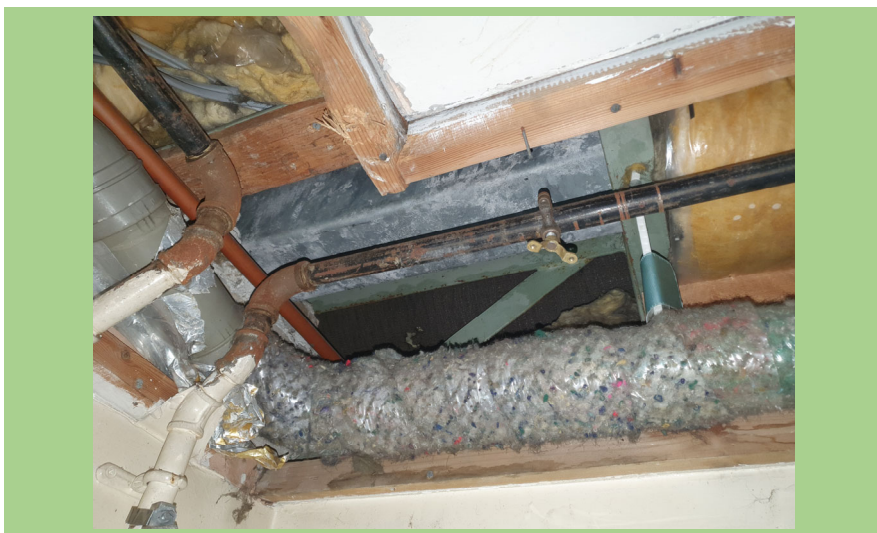
| Sample Number | 45 | No Asbestos Detected |

| Floor, Room | Roof, throughout | Location | Underside of the roof |
| Material | Bituminous felt | Quantity | 1200 sq. m. |

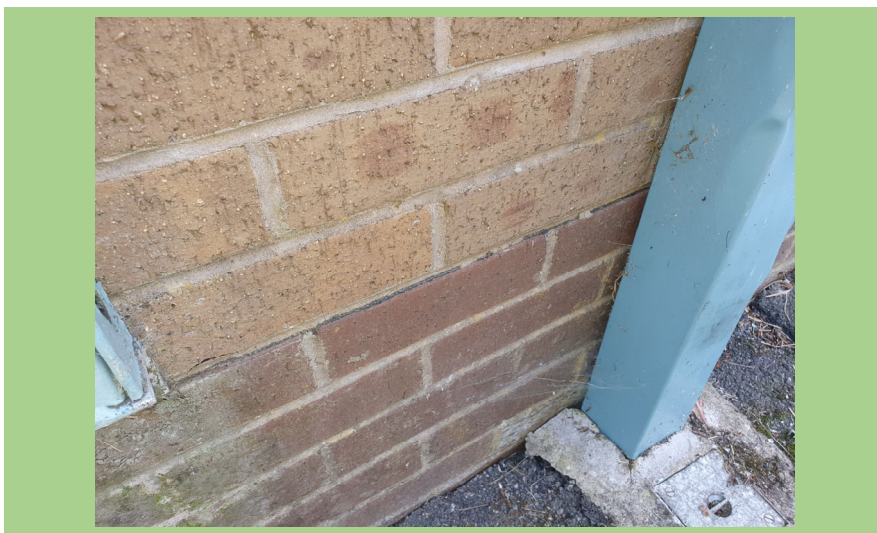
| Sample Number | 46 | No Asbestos Detected |

| Floor, Room | External | Location | Low level brickwork |
| Material | Bitumen damp proof course | Quantity | 150 lin. m. |
