Our Ref: NW134/01/2/OGjcl3

5<sup>th</sup> April 2022

Intrusive Coal Mining Investigation  
Hope High School, Skelmersdale

| Title<br>AS-BUILT ROTARY<br>BOREHOLE<br>LOCATION PLAN | |

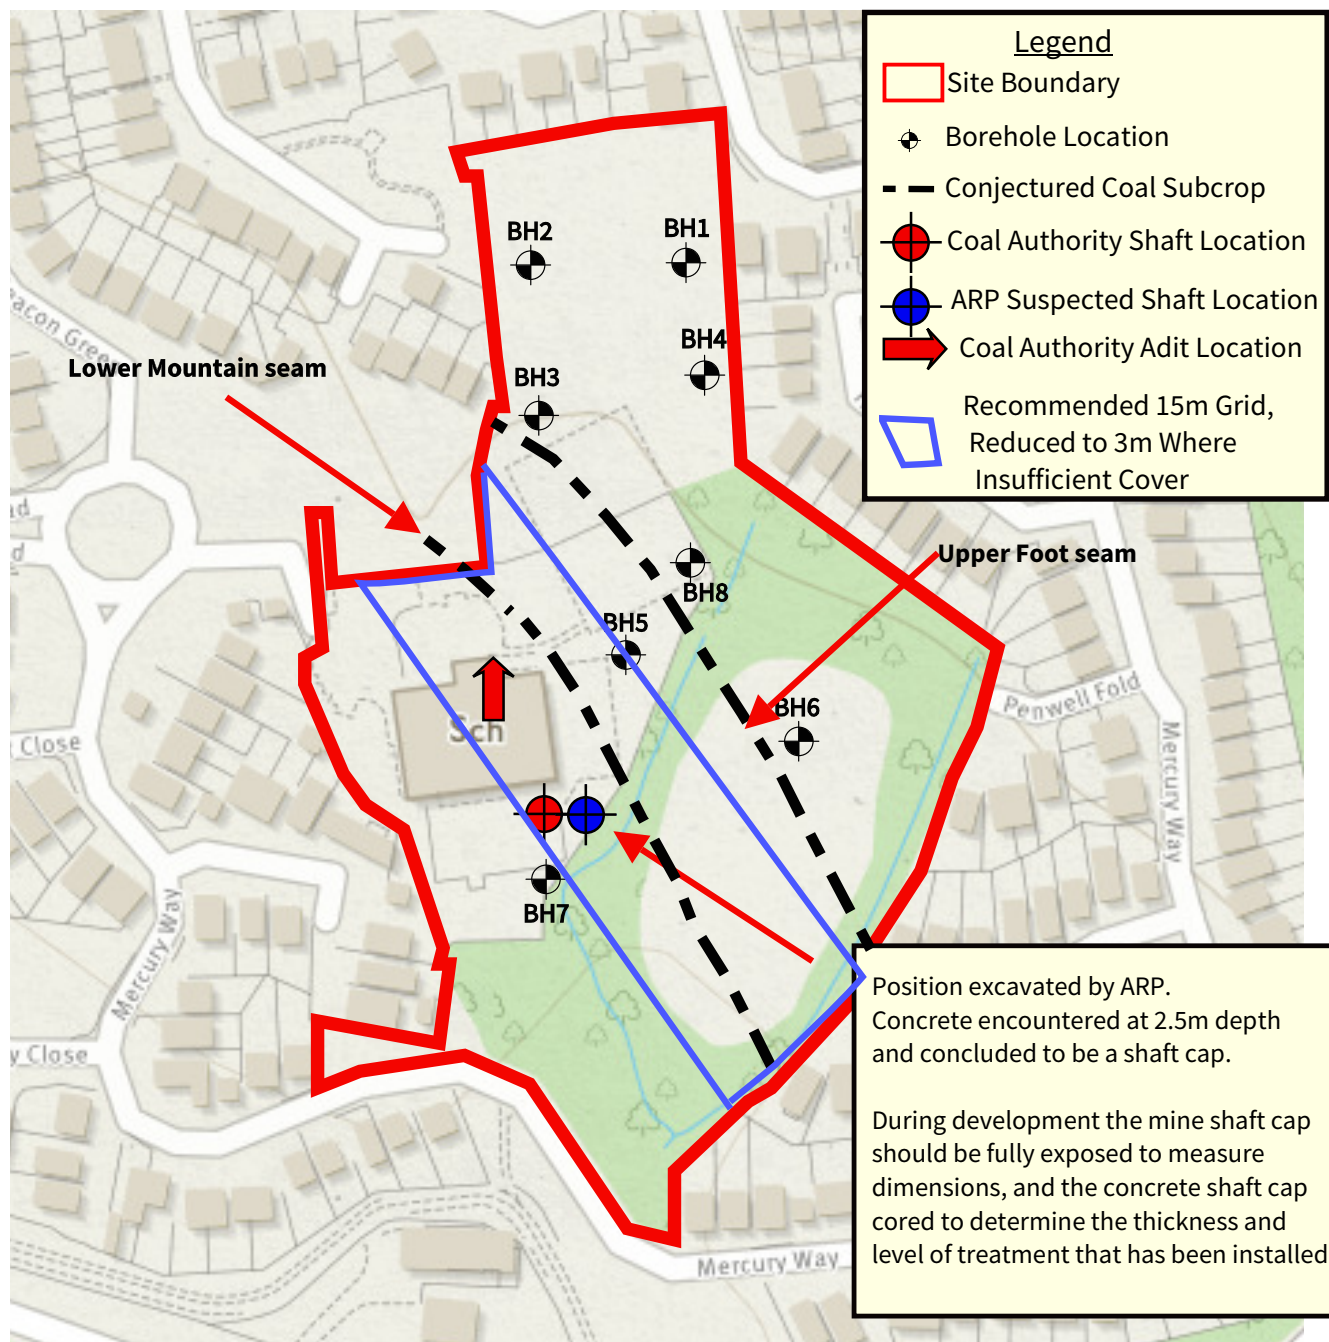
No evidence of coal seam or evidence of workings was identified in BH7, the furthest west of the boreholes. The sub crop of the Lower Mountain occurs between BH5 and BH7, as the seam is only absent from BH7. The approximate position of the seam sub crops is shown on the attached plan.

If development of any pertinent structures (such as houses, roads, drives and parking areas) is proposed on the zone edged blue on the attached plan, it is recommended that the area is drilled/investigated on an initial 15m grid. Where any boreholes show the Lower Mountain coal seam to have less than 6m thickness of rock cover, or where workings are present with less than 6m cover to the original seam roof, then the grid should be reduced to 3m, and grout injected to stabilise the workings.

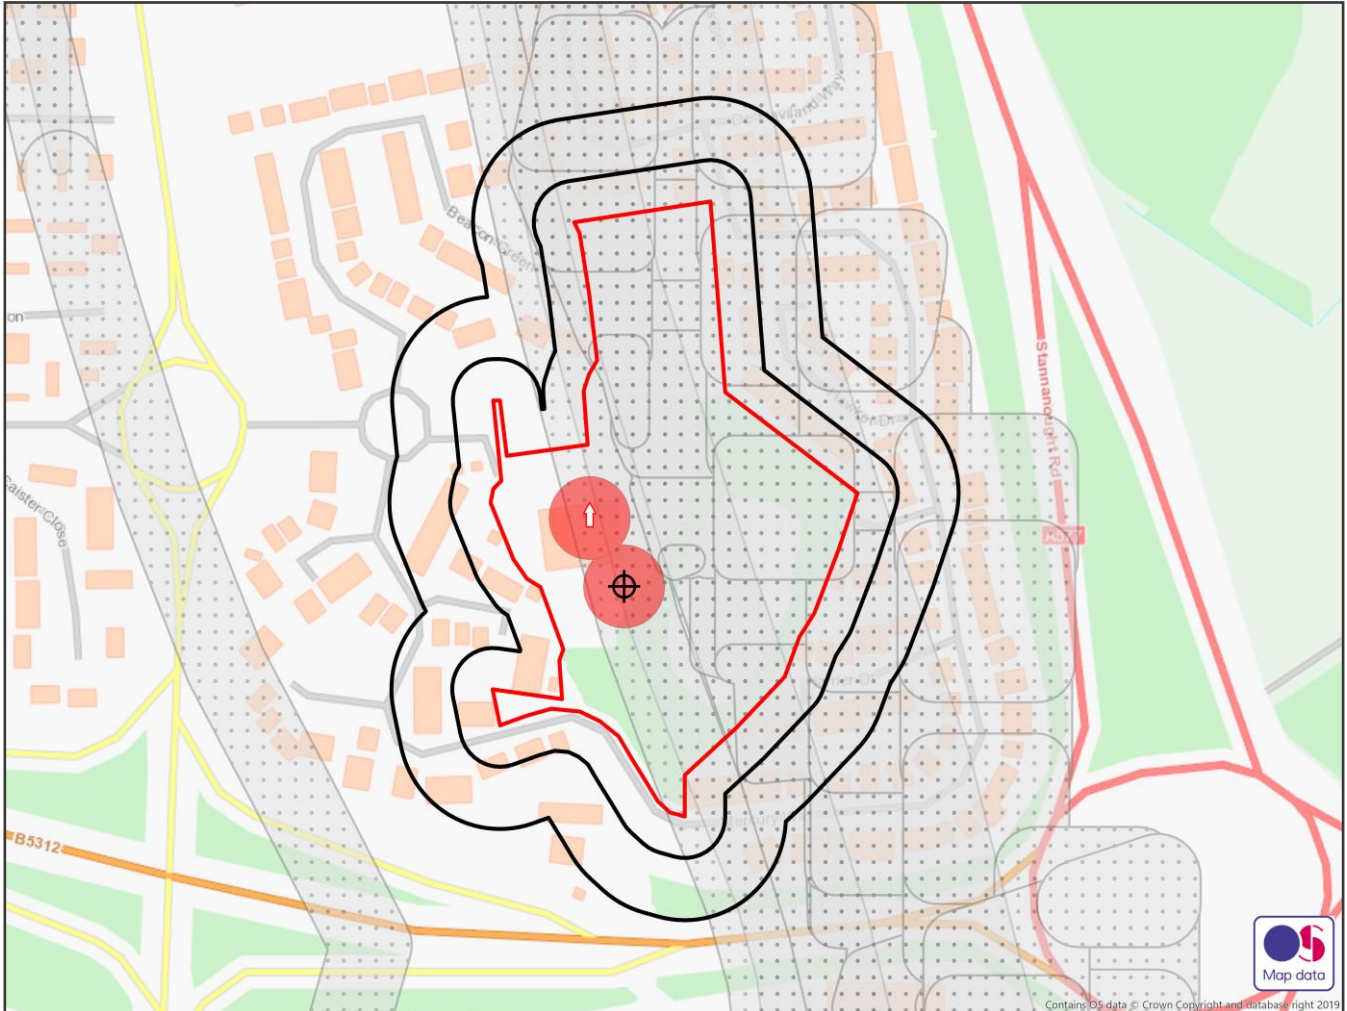
## Mining Hazard Map

Two mine entries are recorded within the central-western part of the Site boundary (see Mining hazard map for documented locations). The northern mine entry is documented to be an adit (a horizontal/near-horizontal entrance into a mine) and the associated adit tunnel is documented to extend to the north-east. The southern mine entry is documented to be a shaft. Both mine entries are documented by the Coal Authority to have been treated by Lancashire County Council in 1973. As the mine entries have been treated, there may be a reduced risk of instability. However, as the details/specifications of treatment works undertaken have not been confirmed within the record, it would be prudent to assume that a residual risk of ground instability remains.

Two coal seams, named “Lower Mountain” and “Upper Foot”, are recorded to outcrop at/near surface beneath the central part of the Site, coursing parallel to each other in a north-south direction. There is an increased potential for unrecorded historical mining features to occur along/near coal outcrops as the coal is easily accessible where it intercepts the surface/near-surface. Such features, which may include mine entries, trial pits and ‘Bell Pits’, can cause subsidence issues where present.

It is recommended that the locations of mine entries (areas marked as ‘Further Investigation Zone’ or ‘Affected Areas’) are monitored for any changes that may be indicative of subsidence.

If there is any change in the site use (e.g. public access or development), it is recommended that the appropriate precautions are taken. This may involve erecting safety fencing around the mine entries or conducting a full mining investigation if development is to be undertaken within the areas marked as ‘Further Investigation Zone’ or ‘Affected Areas’.
