**Issue Date**  
15<sup>th</sup> September 2021

**Reference Number**  
23458

## Asbestos Demolition Survey

**Site Address**  
Former Hope High School  
Tanhouse Road  
Skelmersdale  
WN8 6BA

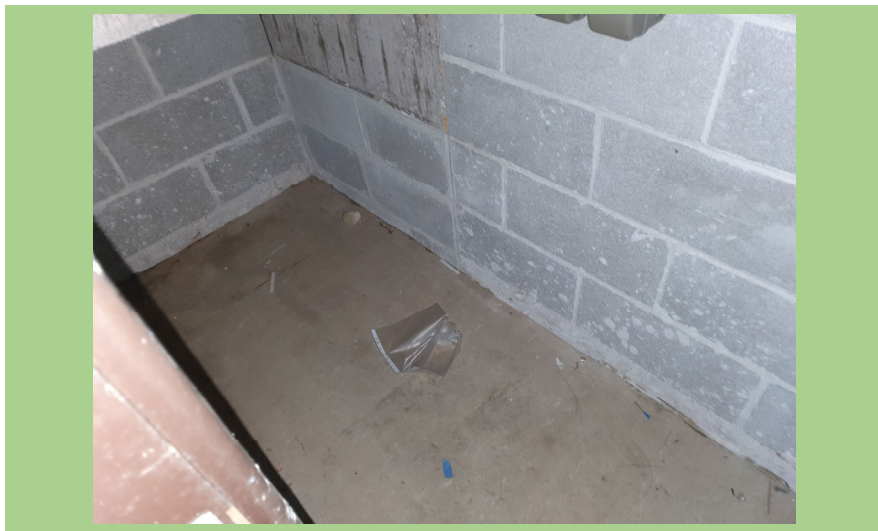
| Sample Number | 4 | No Asbestos Detected |

| Floor, Room | Ground floor, G.08 | Location | Floor |
| Material | Brown linoleum | Quantity | 3 sq. m. |

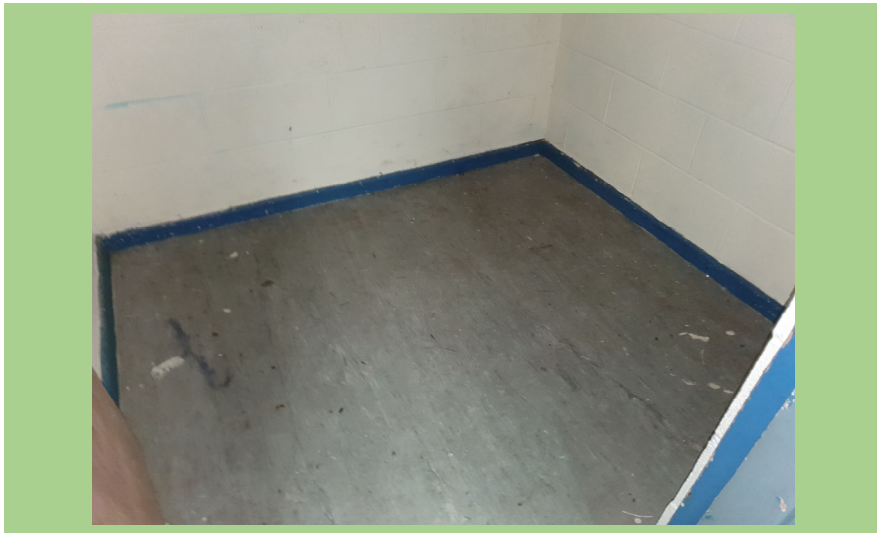
| Sample Number | 5 | No Asbestos Detected |

| Floor, Room | Ground floor, G.10 | Location | Floor |
| Material | Grey linoleum | Quantity | 6 sq. m. |

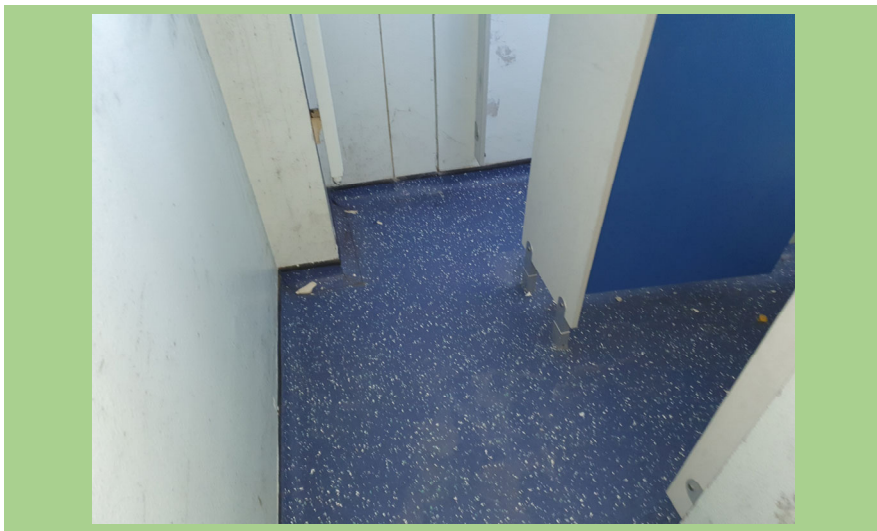
| Sample Number | 6 | No Asbestos Detected |

| Floor, Room | Ground floor, G.14 | Location | Floor |
| Material | Blue linoleum | Quantity | 8 sq. m. |

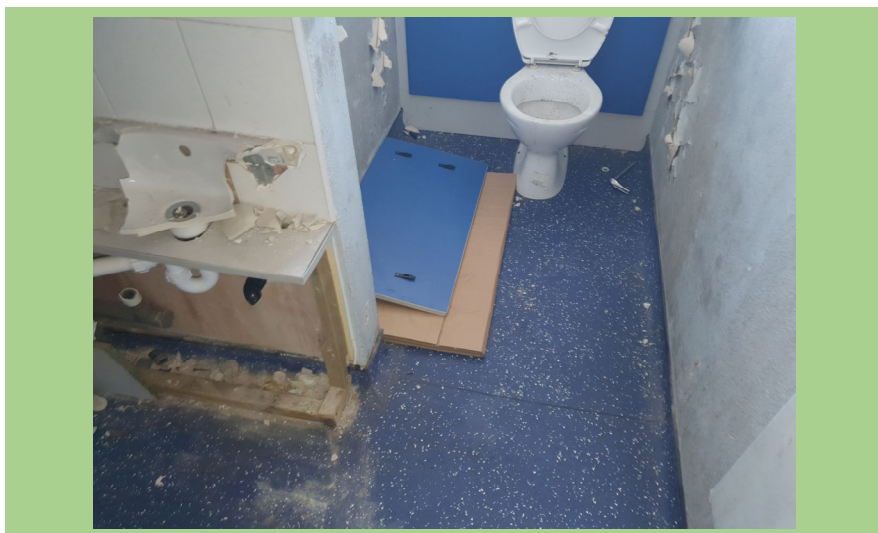
| Sample Number | 7 VI 6 | No Asbestos Detected |

| Floor, Room | Ground floor, G.15 | Location | Floor |
| Material | Blue linoleum | Quantity | 8 sq. m. |

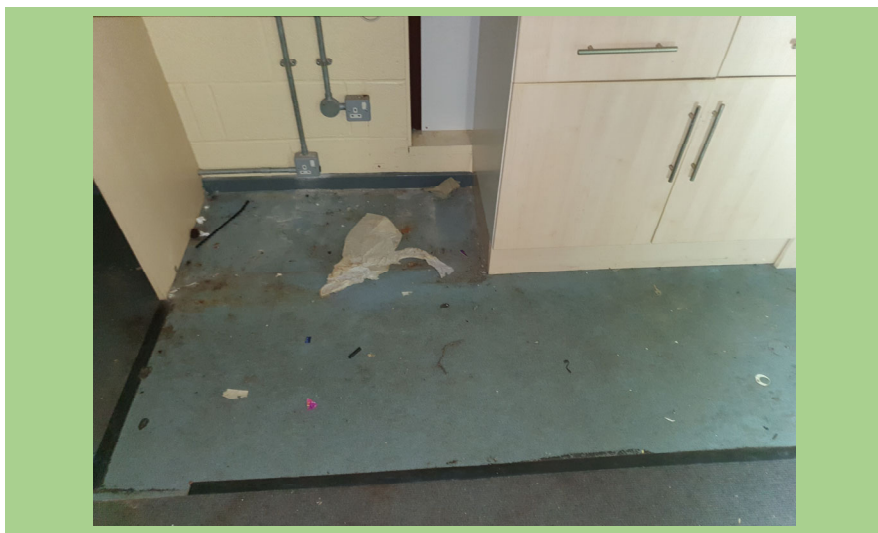
| Sample Number | 8 | No Asbestos Detected |

| Floor, Room | Ground floor, G.18 | Location | Floor |
| Material | Blue linoleum | Quantity | 4 sq. m. |

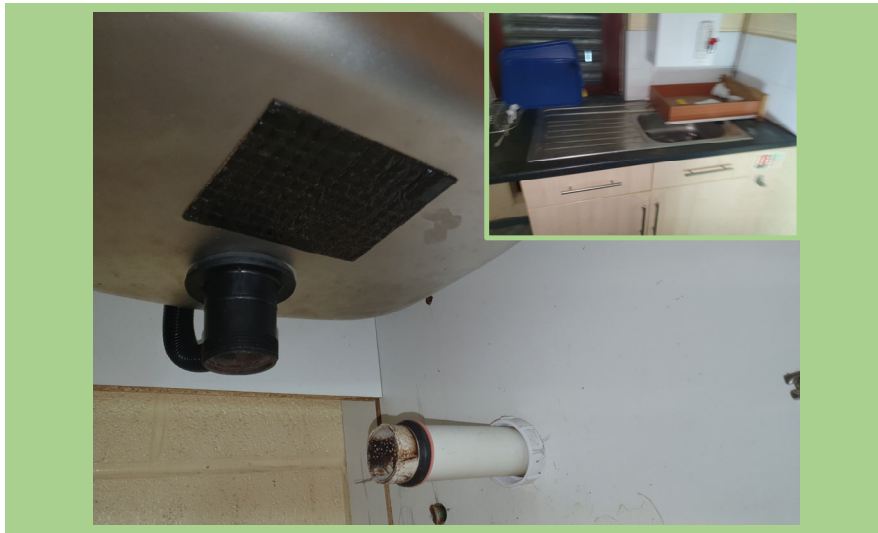
| Sample Number | 9 VI 2 | No Asbestos Detected |

| Floor, Room | Ground floor, G.18 | Location | Underside of the sink |
| Material | Bitumen pads | Quantity | 2 units |

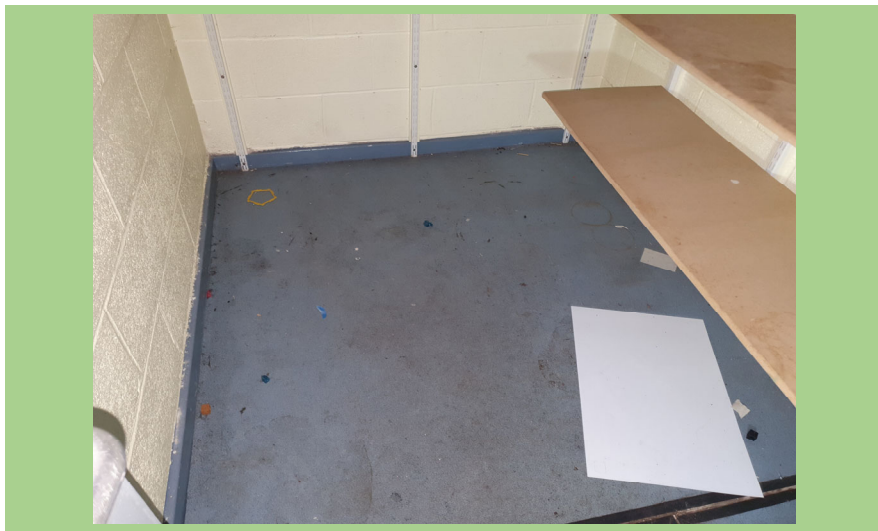
| Sample Number | 10 VI 8 | No Asbestos Detected |

| Floor, Room | Ground floor, G.19 | Location | Floor |
| Material | Blue linoleum | Quantity | 6 sq. m. |

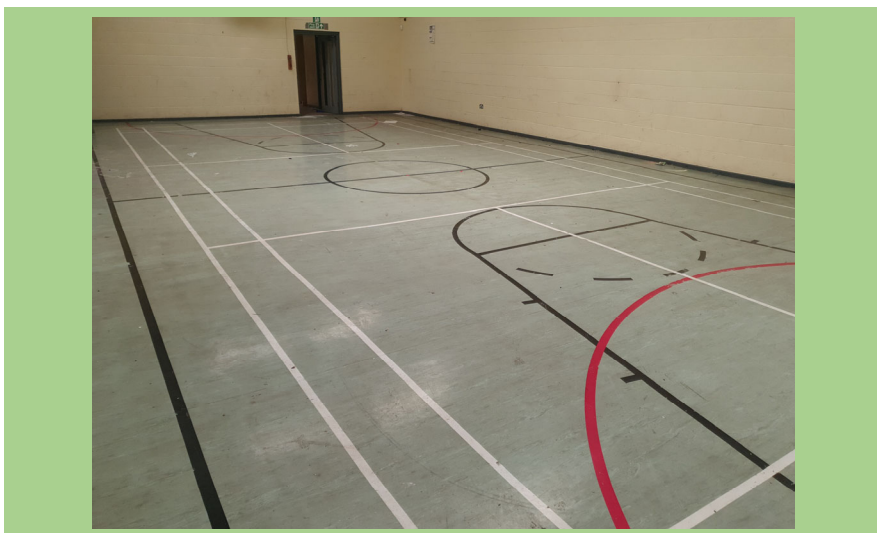
| Sample Number | 11 | No Asbestos Detected |

| Floor, Room | Ground floor, G.22 | Location | Floor |
| Material | Green linoleum | Quantity | 160 sq. m. |

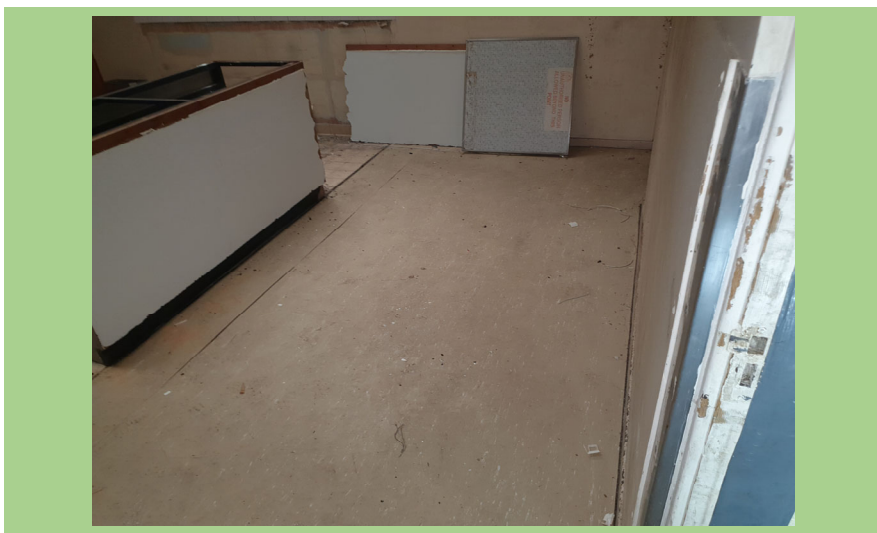
| Sample Number | 12 VI 4 | No Asbestos Detected |

| Floor, Room | Ground floor, G.23 | Location | Floor |
| Material | Brown linoleum | Quantity | 15 sq. m. |

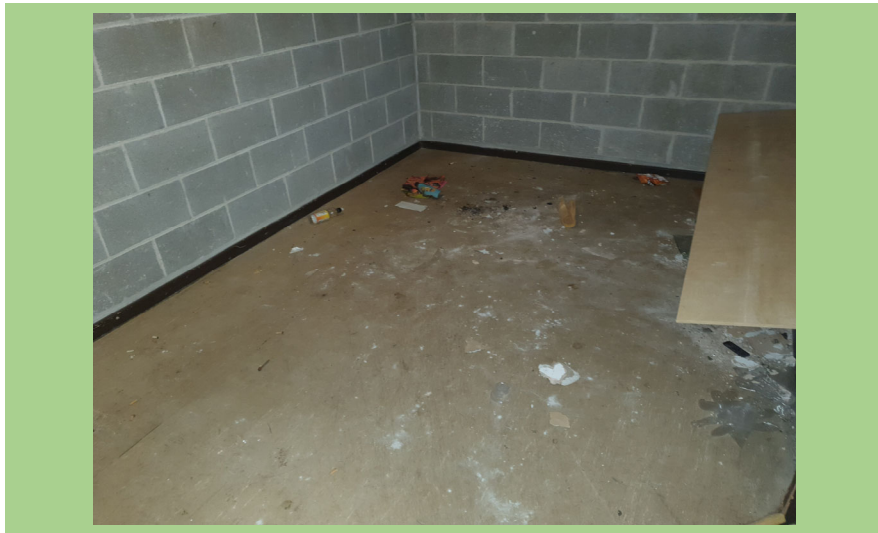
| Sample Number | 13 VI 4 | No Asbestos Detected |

| Floor, Room | Ground floor, G.25 | Location | Floor |
| Material | Brown linoleum | Quantity | 15 sq. m. |

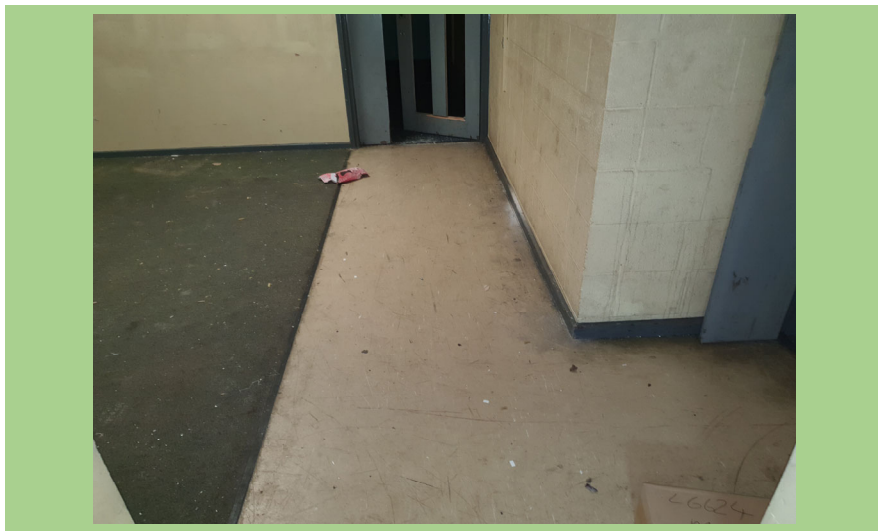
| Sample Number | 14 VI 4 | No Asbestos Detected |

| Floor, Room | Ground floor, G.26 | Location | Floor |
| Material | Brown linoleum | Quantity | 8 sq. m. |

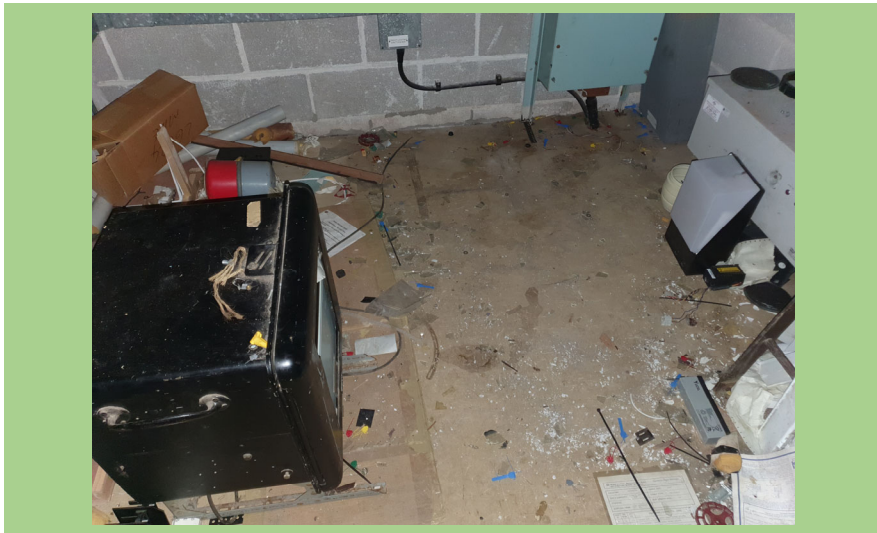
| Sample Number | 15 VI 4 | No Asbestos Detected |

| Floor, Room | Ground floor, G.27 | Location | Floor |
| Material | Brown linoleum | Quantity | 9 sq. m. |

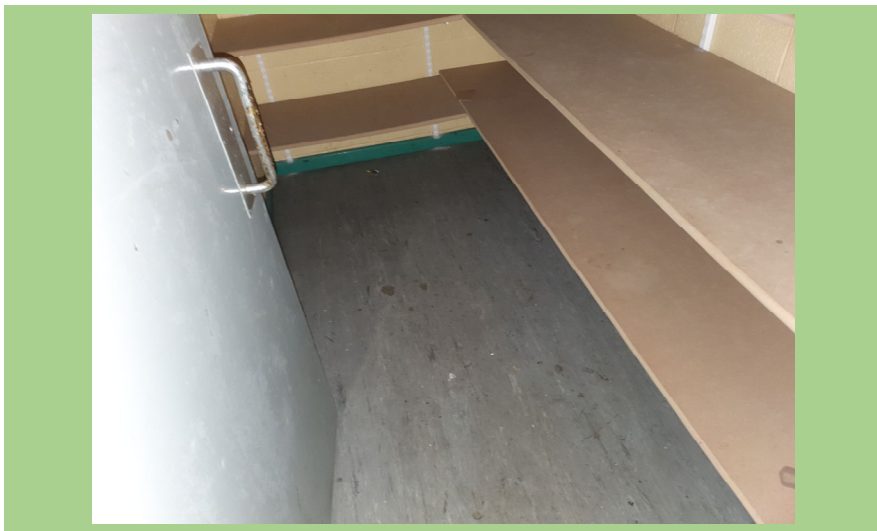
| Sample Number | 16 VI 5 | No Asbestos Detected |

| Floor, Room | Ground floor, G.29 | Location | Floor |
| Material | Grey linoleum | Quantity | 4 sq. m. |

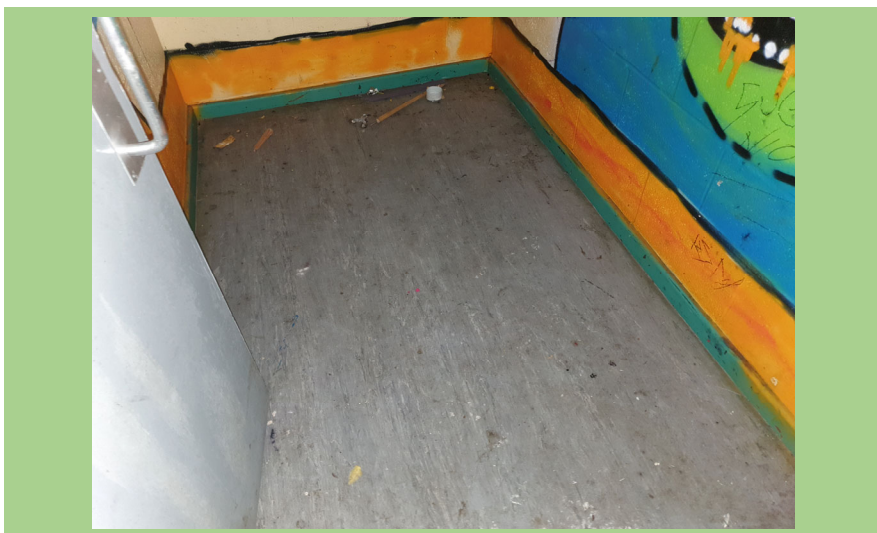
| Sample Number | 17 VI 5 | No Asbestos Detected |

| Floor, Room | Ground floor, G.30 | Location | Floor |
| Material | Grey linoleum | Quantity | 4 sq. m. |

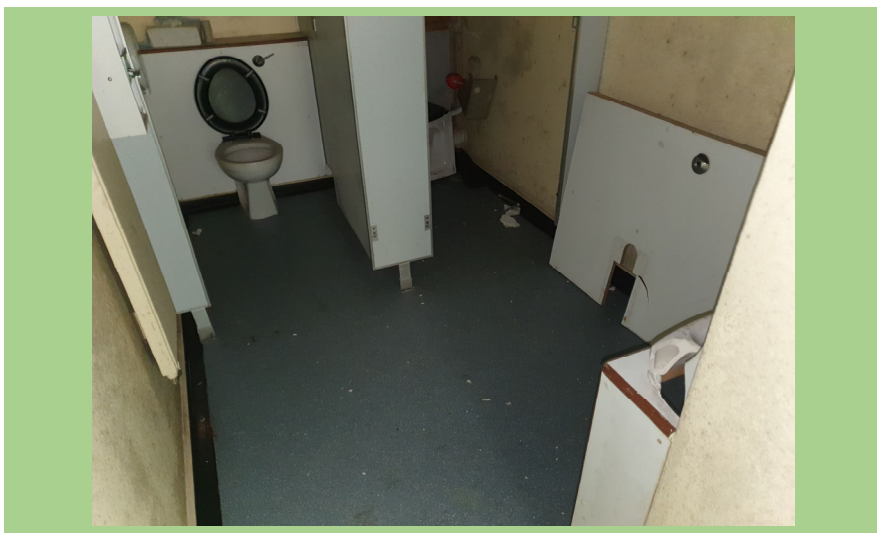
| Sample Number | 18 VI 6 | No Asbestos Detected |

| Floor, Room | Ground floor, G.34 | Location | Floor |
| Material | Blue linoleum | Quantity | 8 sq. m. |

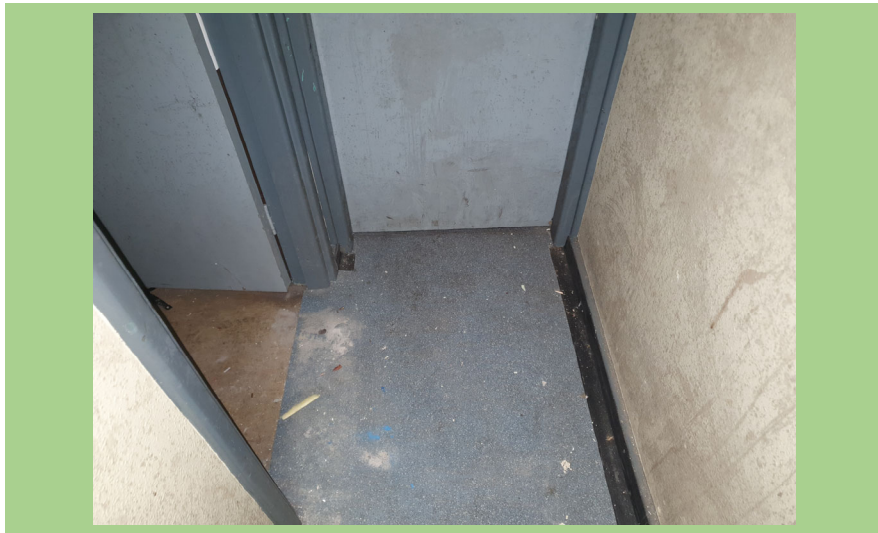
| Sample Number | 19 VI 6 | No Asbestos Detected |

| Floor, Room | Ground floor, G.35 | Location | Floor |
| Material | Blue linoleum | Quantity | 8 sq. m. |

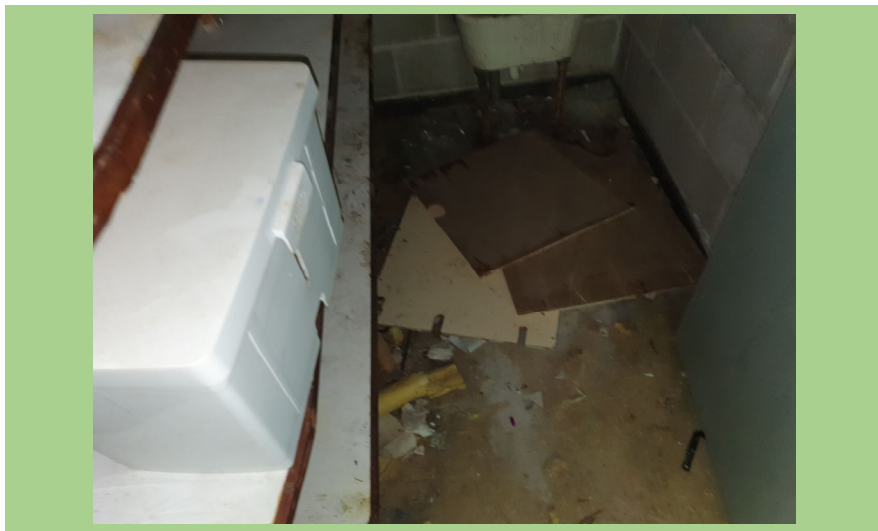
| Sample Number | 20 VI 4 | No Asbestos Detected |

| Floor, Room | Ground floor, G.36 | Location | Floor |
| Material | Brown linoleum | Quantity | 3 sq. m. |

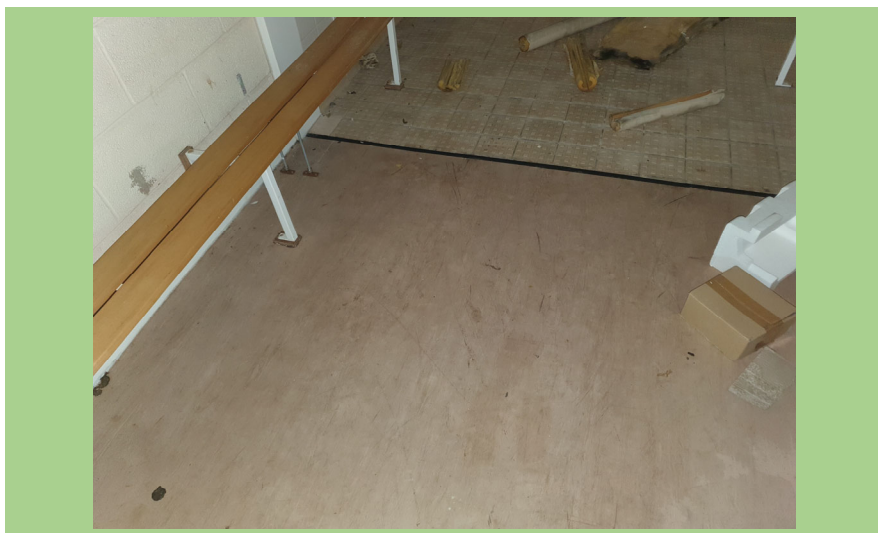
| Sample Number | 21 VI 4 | No Asbestos Detected |

| Floor, Room | Ground floor, G.37 | Location | Floor |
| Material | Brown linoleum | Quantity | 12 sq. m. |

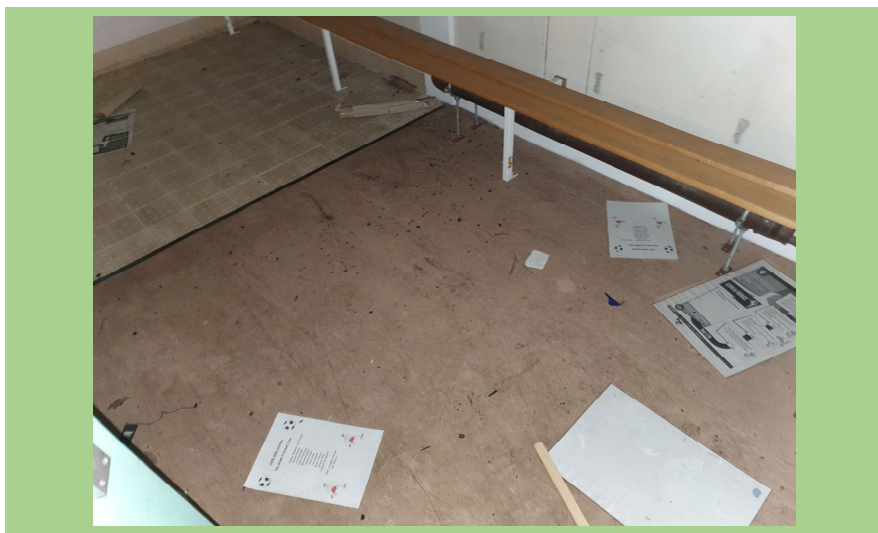
| Sample Number | 22 VI 4 | No Asbestos Detected |

| Floor, Room | Ground floor, G.38 | Location | Floor |
| Material | Brown linoleum | Quantity | 12 sq. m. |

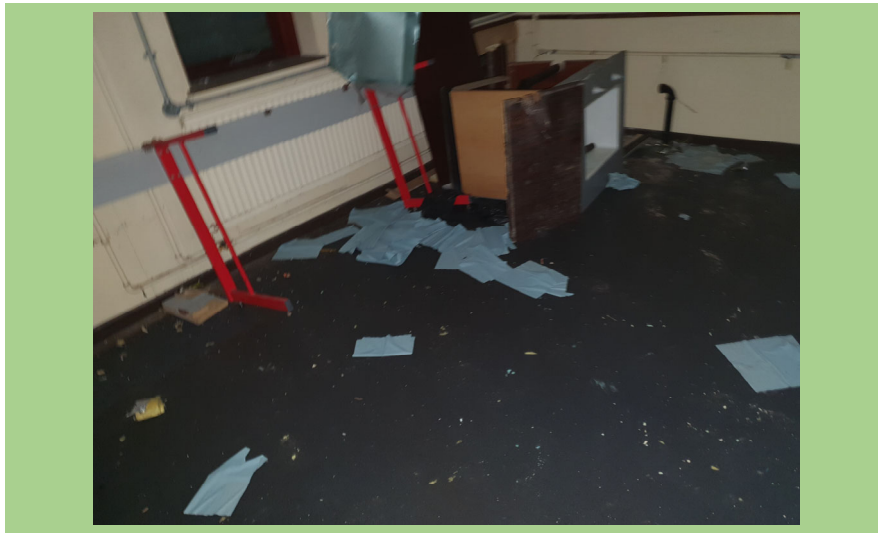
| Sample Number | 23 | No Asbestos Detected |

| Floor, Room | Ground floor, G.40 | Location | Floor |
| Material | Blue linoleum | Quantity | 40 sq. m. |

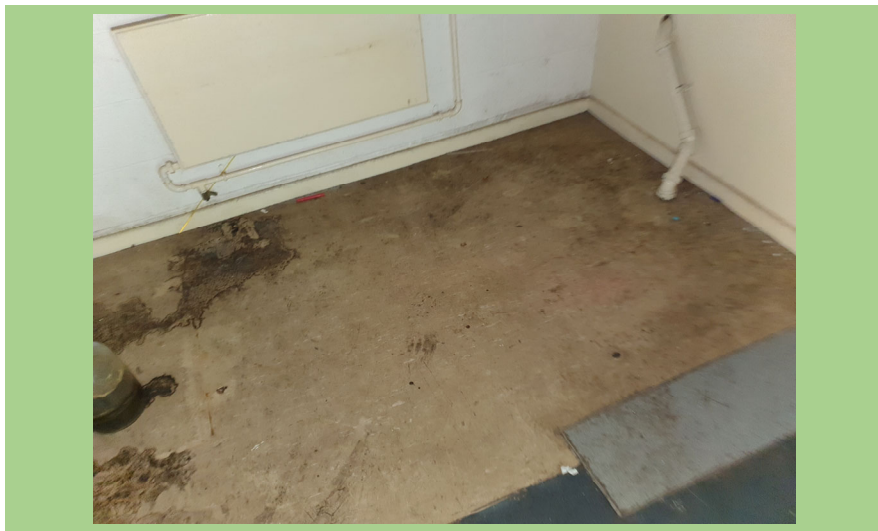
| Sample Number | 24 VI 4 | No Asbestos Detected |

| Floor, Room | Ground floor, G.41 | Location | Floor |
| Material | Brown linoleum | Quantity | 4 sq. m. |

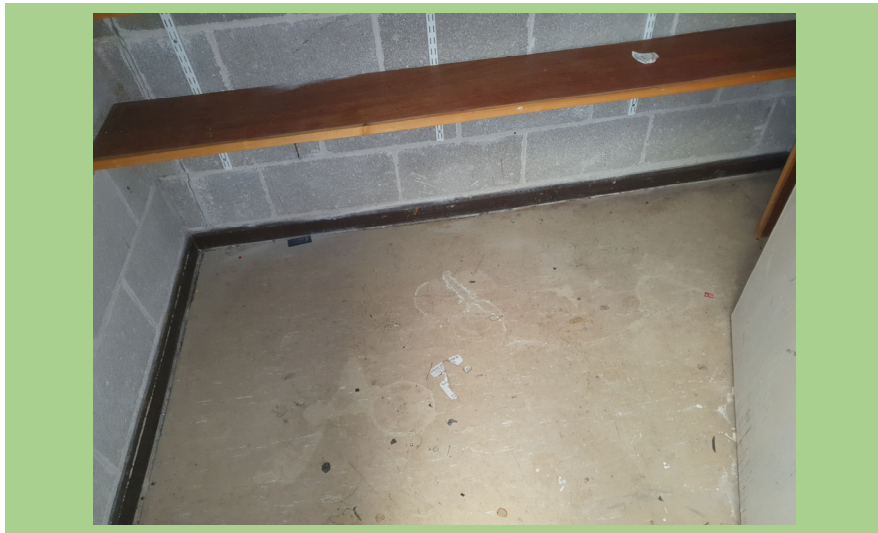
| Sample Number | 25 VI 4 | No Asbestos Detected |

| Floor, Room | Ground floor, G.46 | Location | Floor |
| Material | Brown linoleum | Quantity | 6 sq. m. |

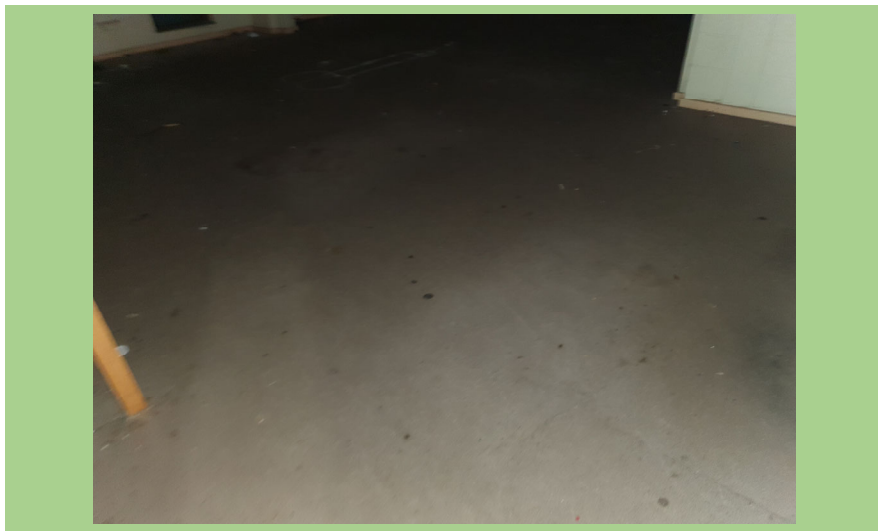
| Sample Number | 26 | No Asbestos Detected |

| Floor, Room | Ground floor, G.42 | Location | Floor |
| Material | Brown linoleum | Quantity | 80 sq. m. |

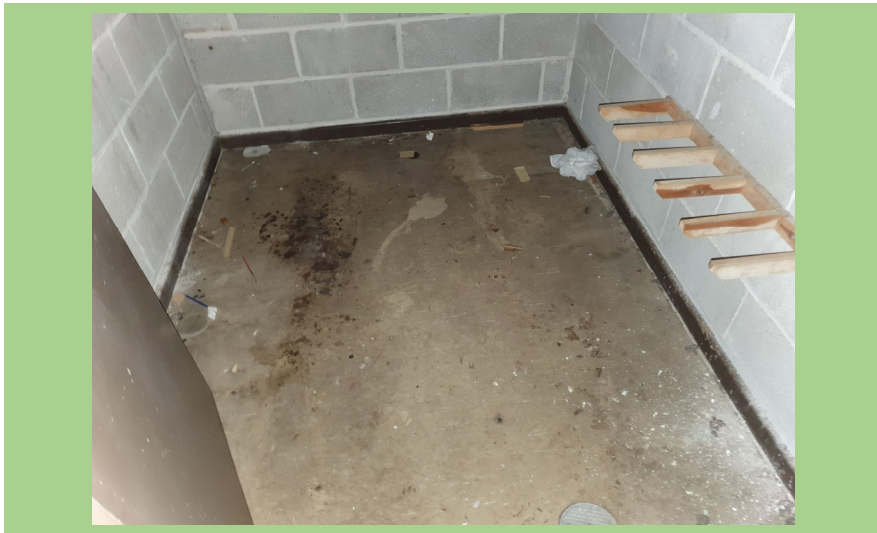
| Sample Number | 27 VI 4 | No Asbestos Detected |

| Floor, Room | Ground floor, G.43 | Location | Floor |
| Material | Brown linoleum | Quantity | 6 sq. m. |

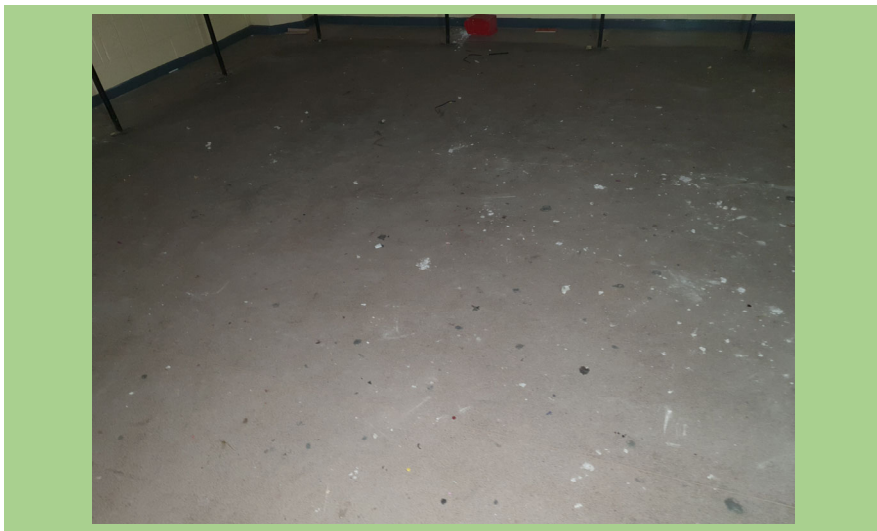
| Sample Number | 28 VI 26 | No Asbestos Detected |

| Floor, Room | Ground floor, G.44 | Location | Floor |
| Material | Brown linoleum | Quantity | 30 sq. m. |

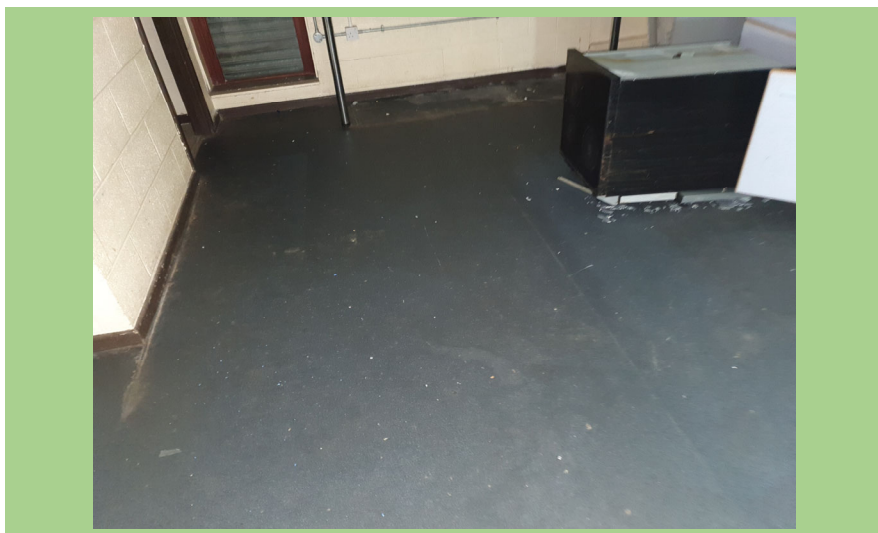
| Sample Number | 29 VI 23 | No Asbestos Detected |

| Floor, Room | Ground floor, G.47 | Location | Floor |
| Material | Blue linoleum | Quantity | 25 sq. m. |

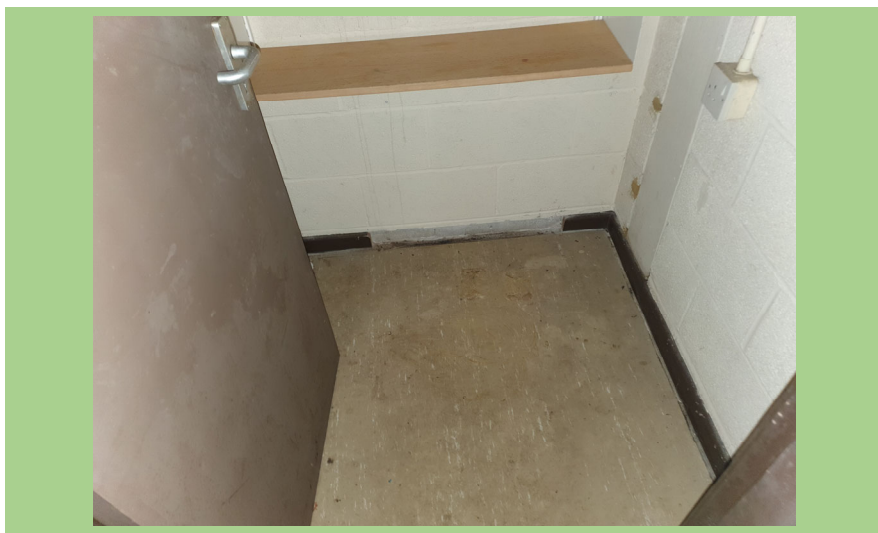
| Sample Number | 30 VI 4 | No Asbestos Detected |

| Floor, Room | Ground floor, G.47 | Location | Floor in the cupboard |
| Material | Brown linoleum | Quantity | 2 sq. m. |

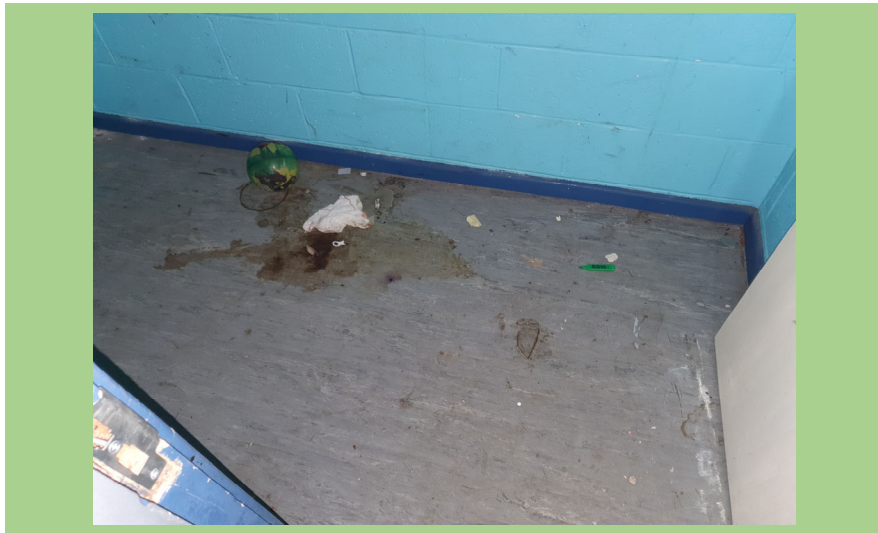
| Sample Number | 31 VI 5 | No Asbestos Detected |

| Floor, Room | Ground floor, G.49 | Location | Floor |
| Material | Grey linoleum | Quantity | 6 sq. m. |

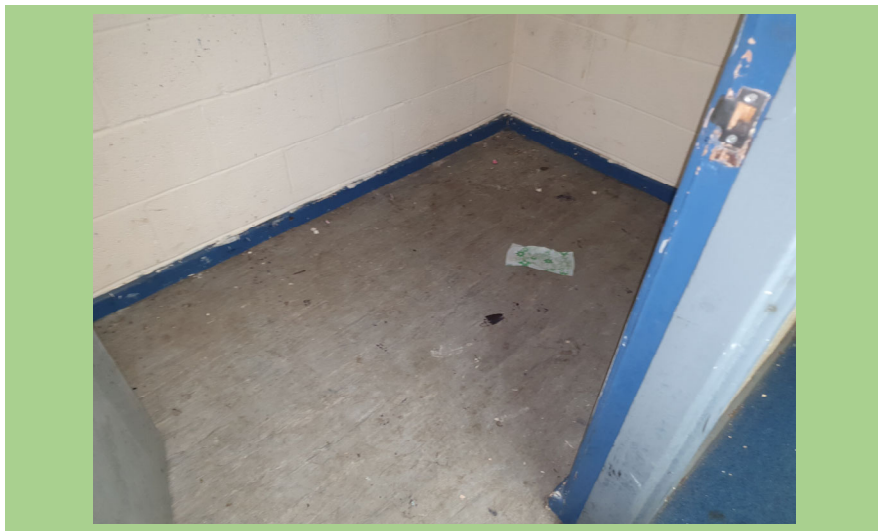
| Sample Number | 32 VI 5 | No Asbestos Detected |

| Floor, Room | Ground floor, G.50 | Location | Floor |
| Material | Grey linoleum | Quantity | 6 sq. m. |

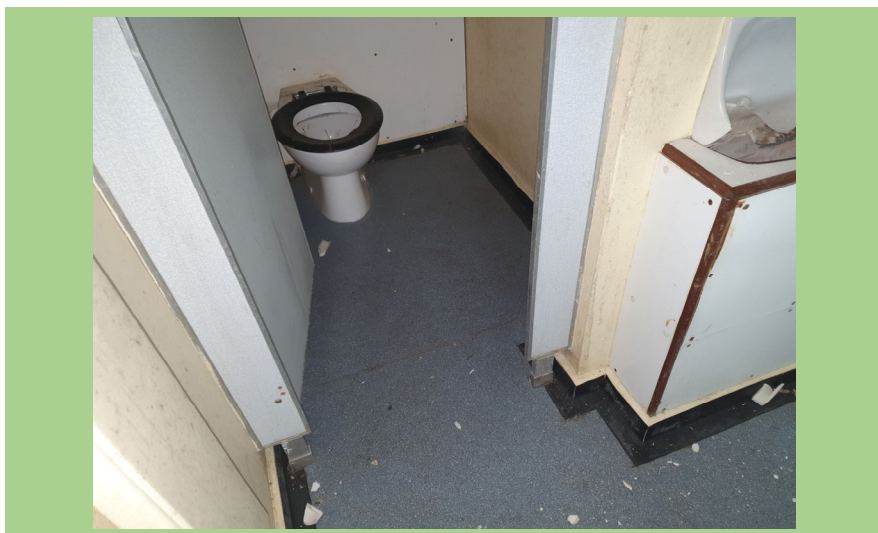
| Sample Number | 33 VI 6 | No Asbestos Detected |

| Floor, Room | Ground floor, G.53 | Location | Floor |
| Material | Blue linoleum | Quantity | 8 sq. m. |

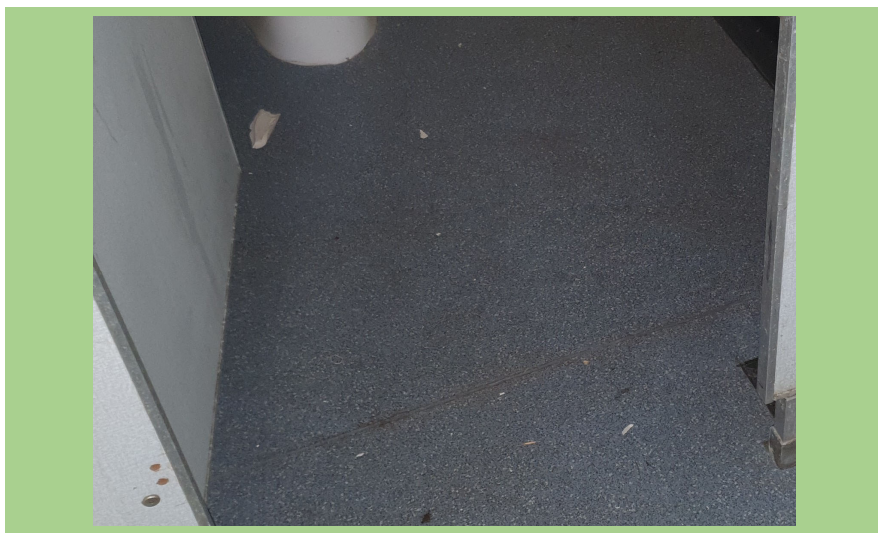
| Sample Number | 34 VI 6 | No Asbestos Detected |

| Floor, Room | Ground floor, G.54 | Location | Floor |
| Material | Blue linoleum | Quantity | 8 sq. m. |

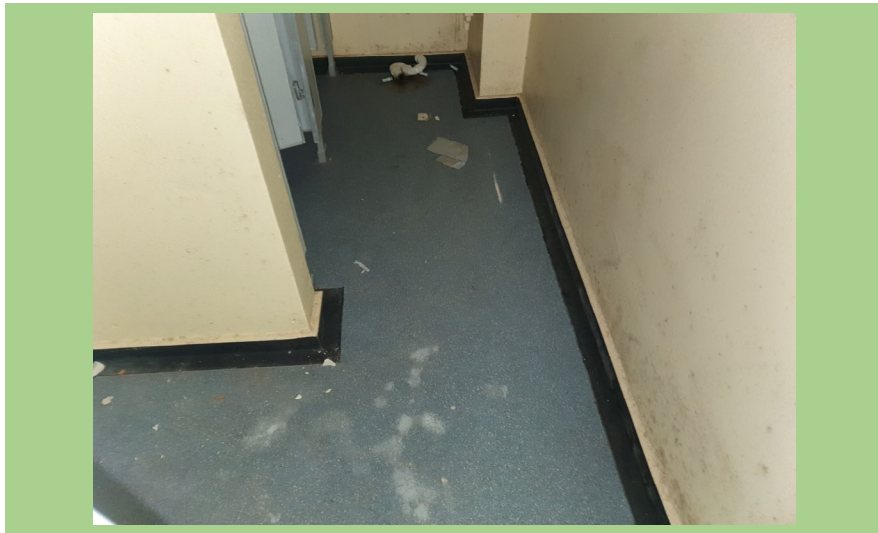
| Sample Number | 35 | No Asbestos Detected |

| Floor, Room | Ground floor, G.59 | Location | Floor |
| Material | Blue linoleum | Quantity | 4 sq. m. |

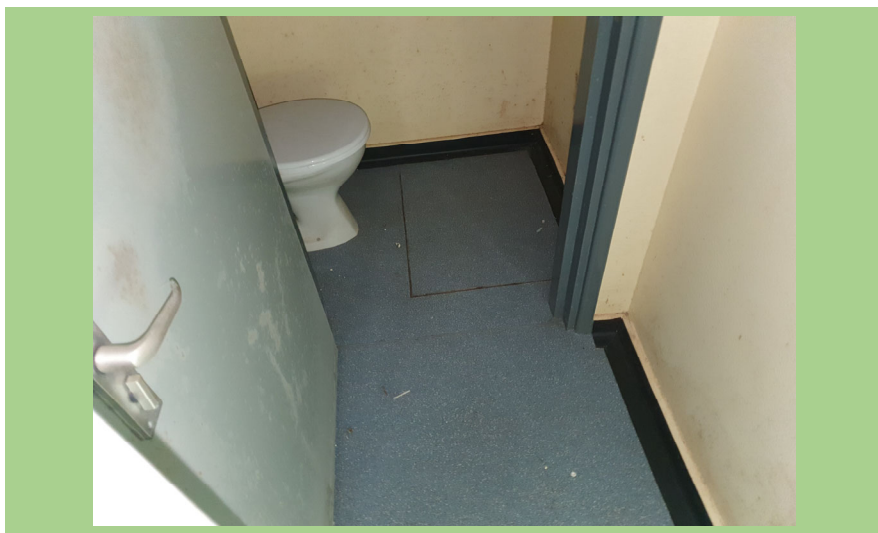
| Sample Number | 36 VI 35 | No Asbestos Detected |

| Floor, Room | Ground floor, G.60 | Location | Floor |
| Material | Blue linoleum | Quantity | 4 sq. m. |

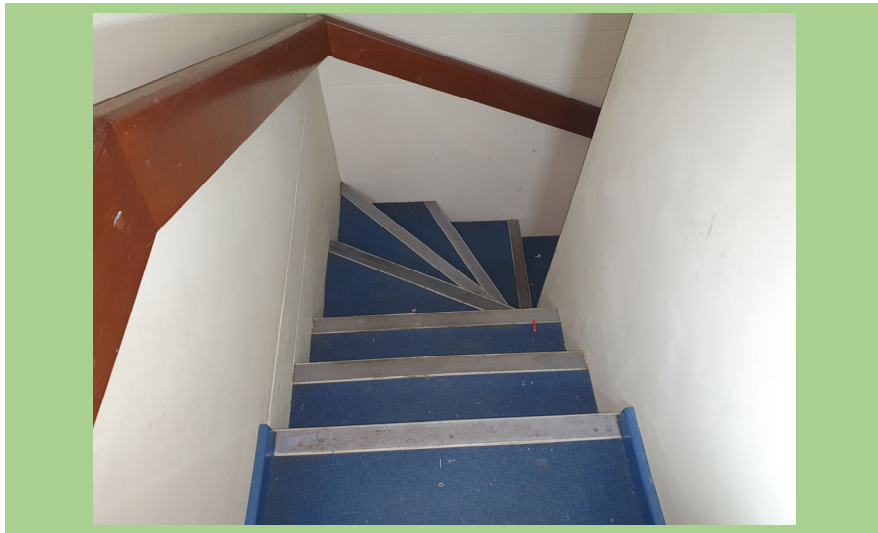
| Sample Number | 37 | No Asbestos Detected |

| Floor, Room | Stairwell, ST.01 | Location | Step treads |
| Material | Grey stair nosing | Quantity | 12 units |

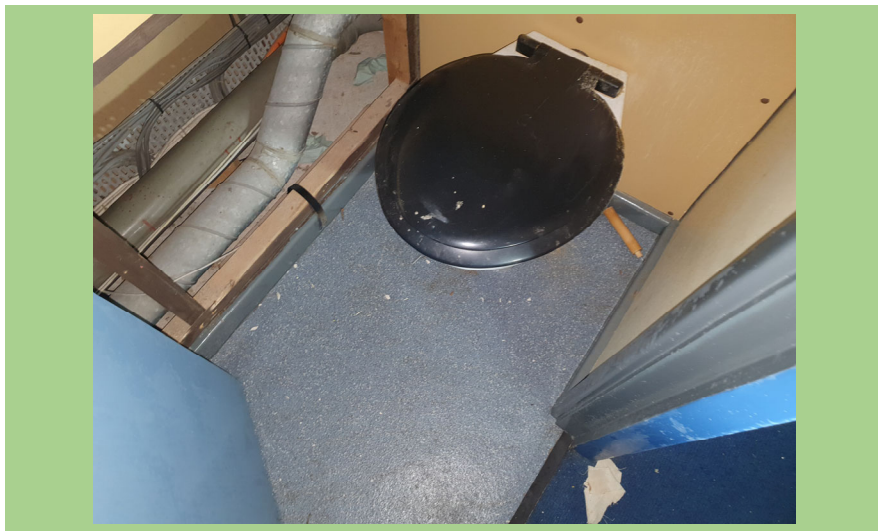
| Sample Number | 38 VI 35 | No Asbestos Detected |

| Floor, Room | First floor, 1.02 | Location | Floor |
| Material | Blue linoleum | Quantity | 2 sq. m. |

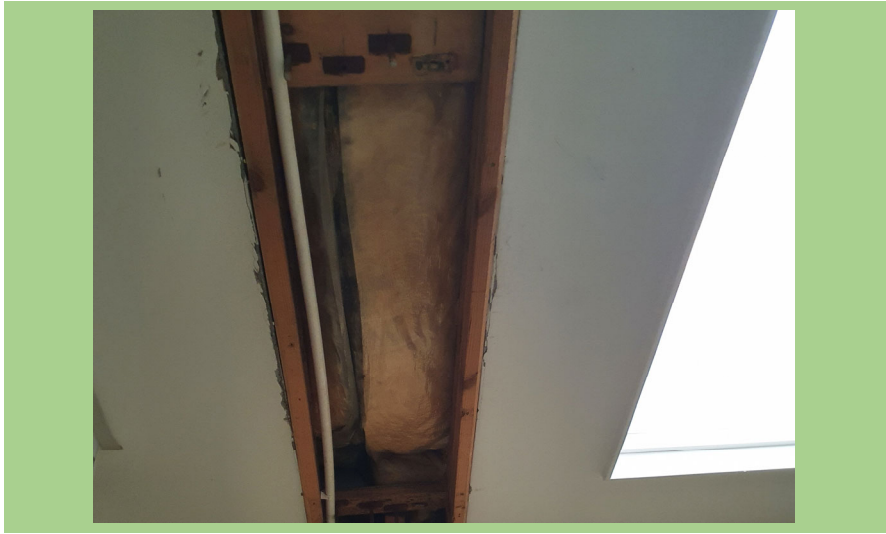
| Sample Number | 47 VI 43 | No Asbestos Detected |

| Floor, Room | Ground floor, throughout | Location | Within the wall and ceiling voids |
| Material | Insulation | Quantity | 500 sq. m. |

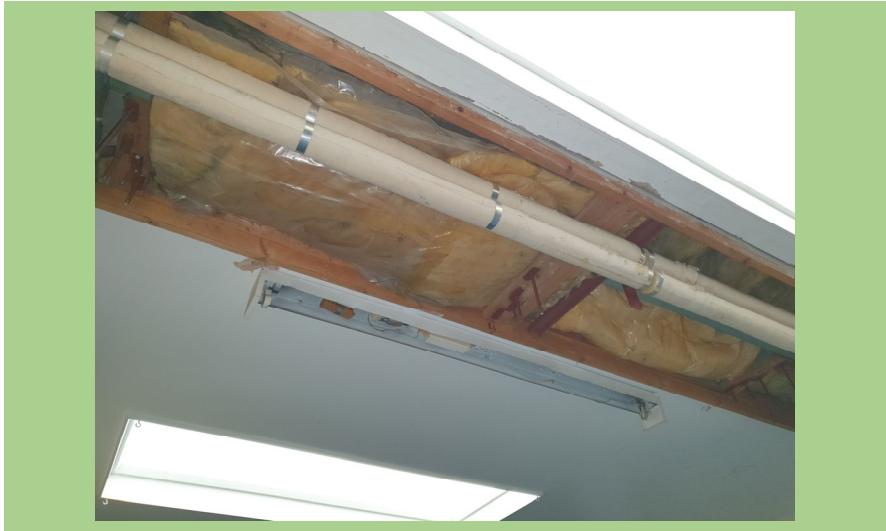
| | 48 VI 44 | No Asbestos Detected |

| | Ground floor, throughout | | Pipework throughout |
| | Insulation | | 50 lin. m. |
